CSC Charlotte South

EPA R4 NPDES Inspection

Inspected on 5/29/19

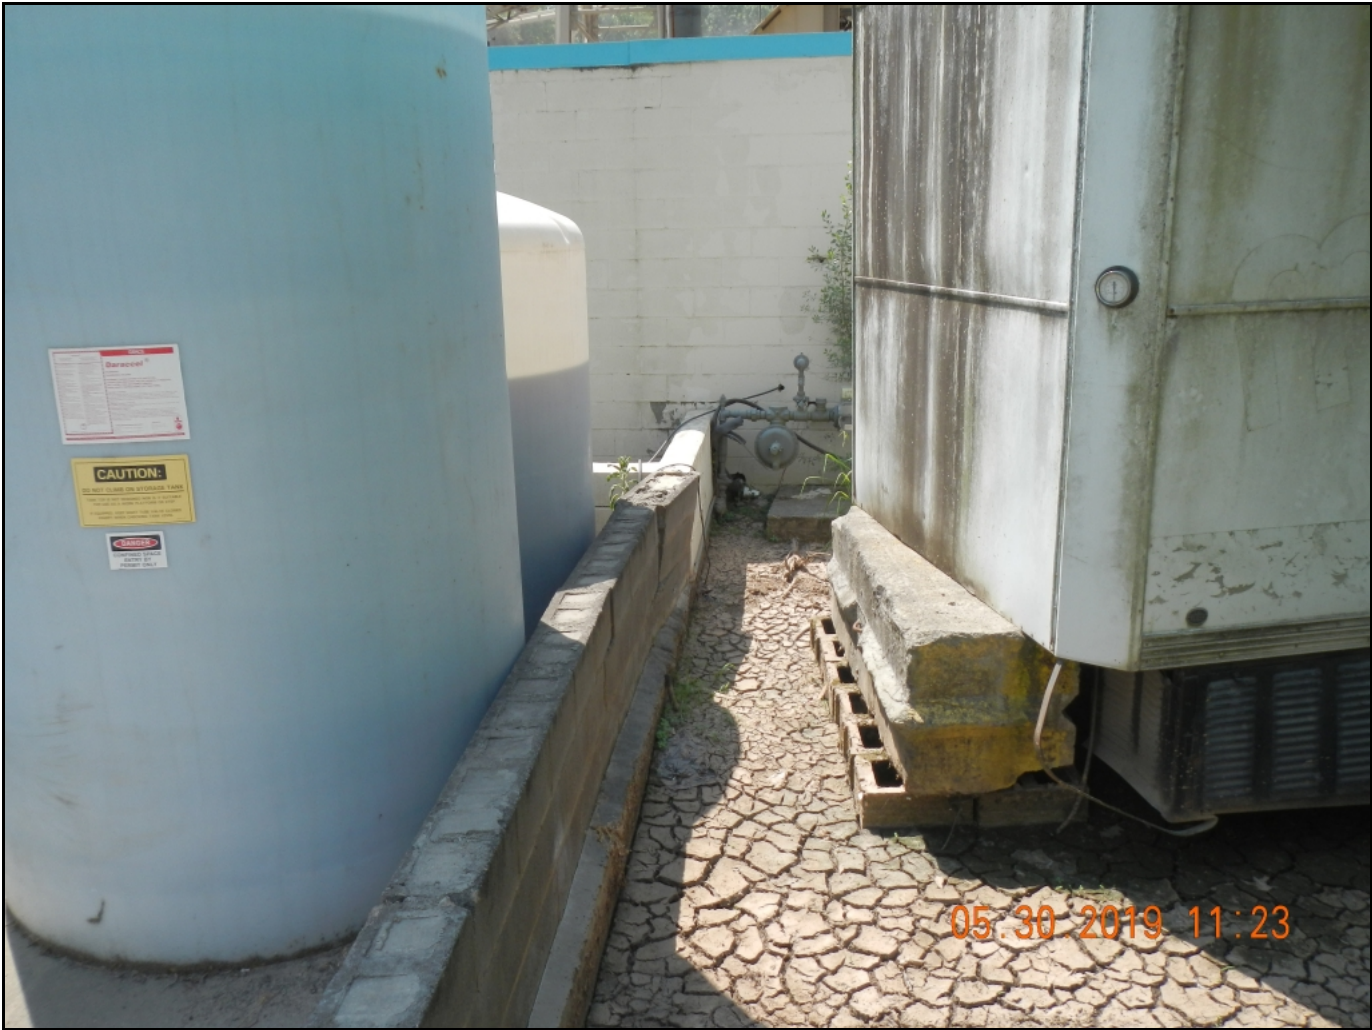
Attributes	
Description	Secondary containment for admixture tanks is broken in this location and two other locations, not shown. Rainwater and spilled liquid from this area would flow into overall site capture tanks shown in later photos.

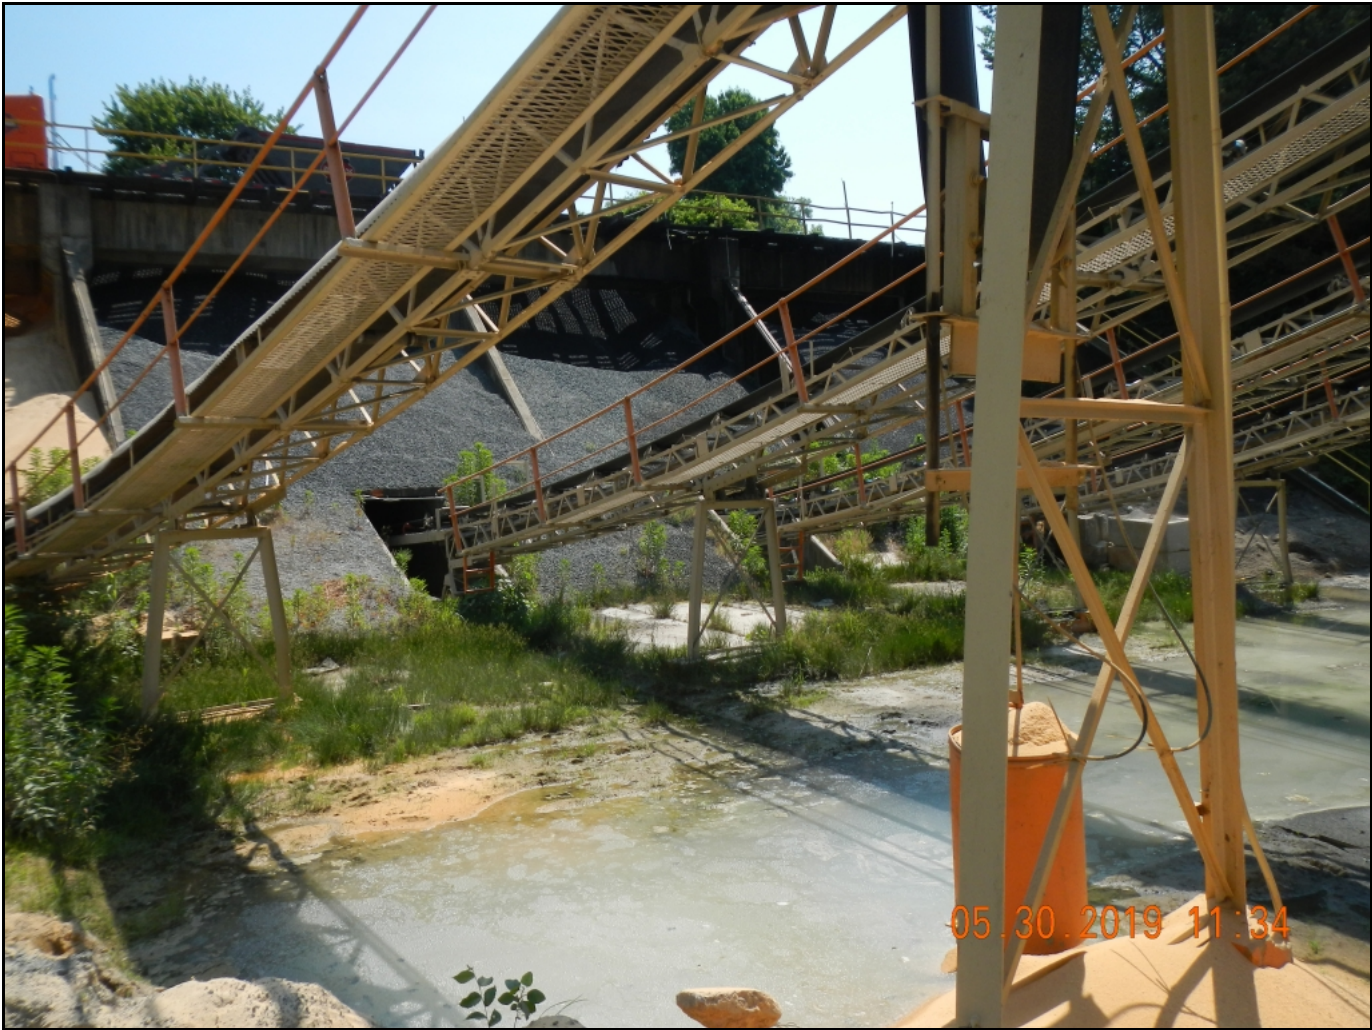
Attributes	
Description	First of two shots of the area below the aggregate storage bins, and the aggregate and sand conveyor belts. Aggregate and sand materials typically have some moisture content. This area also experiences rainfall on these piles and from the northerly portion of the work area, which is captured nearby. Trucks are emptied into the bins from the bridge above.

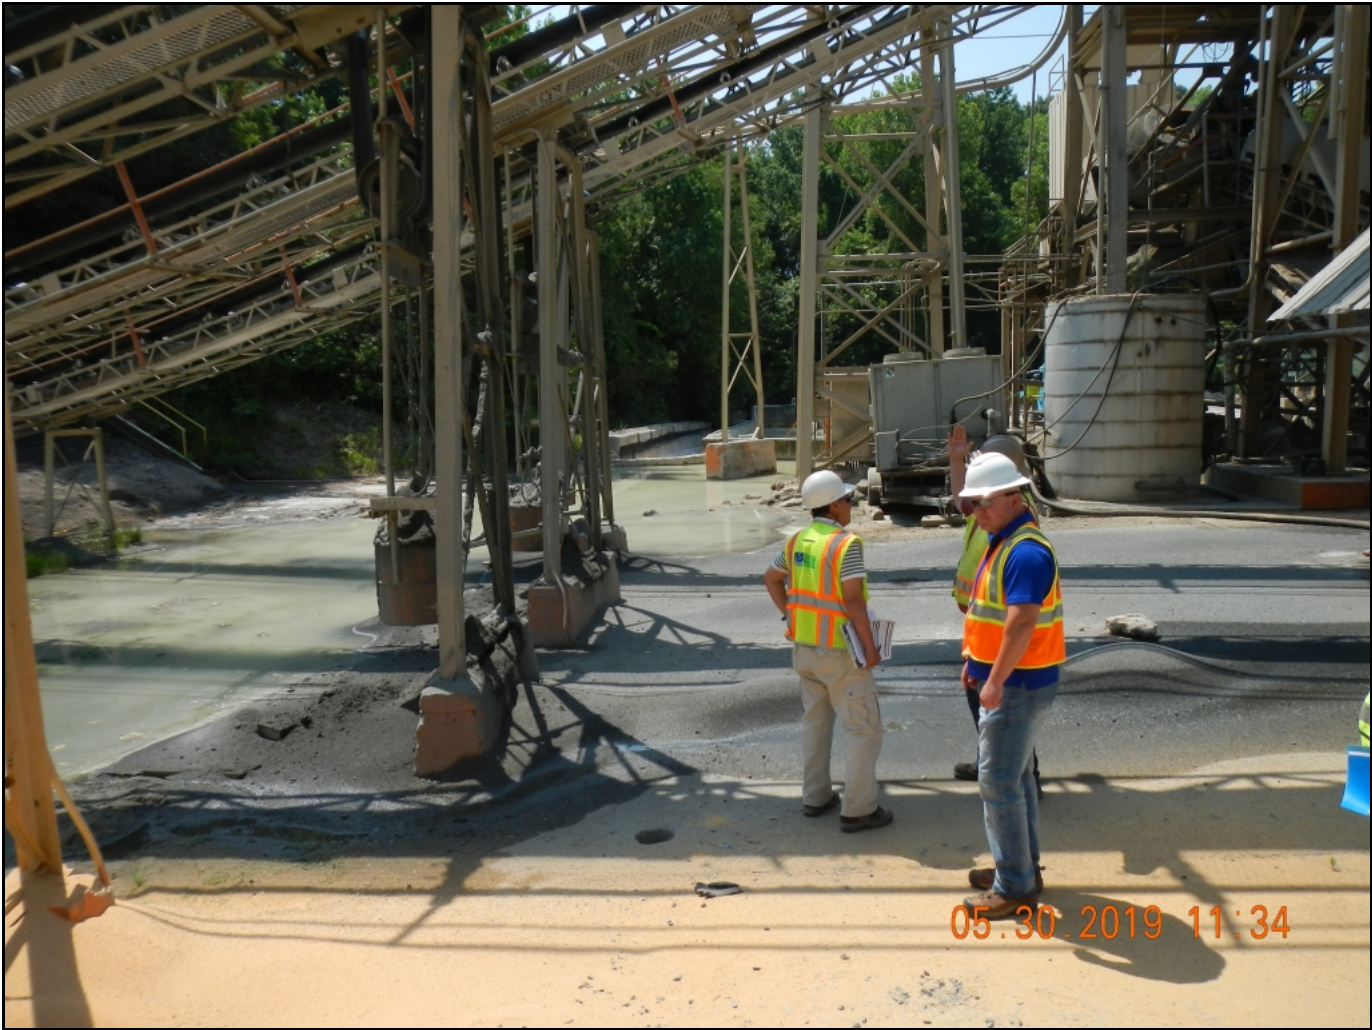
Attributes	
Description	Second view of area below aggregate/sand belts. In background but not shown (between piers and trees, right-middle of photo) is the area that captures the stormwater hitting this area. Water flow and camera angle are southerly.

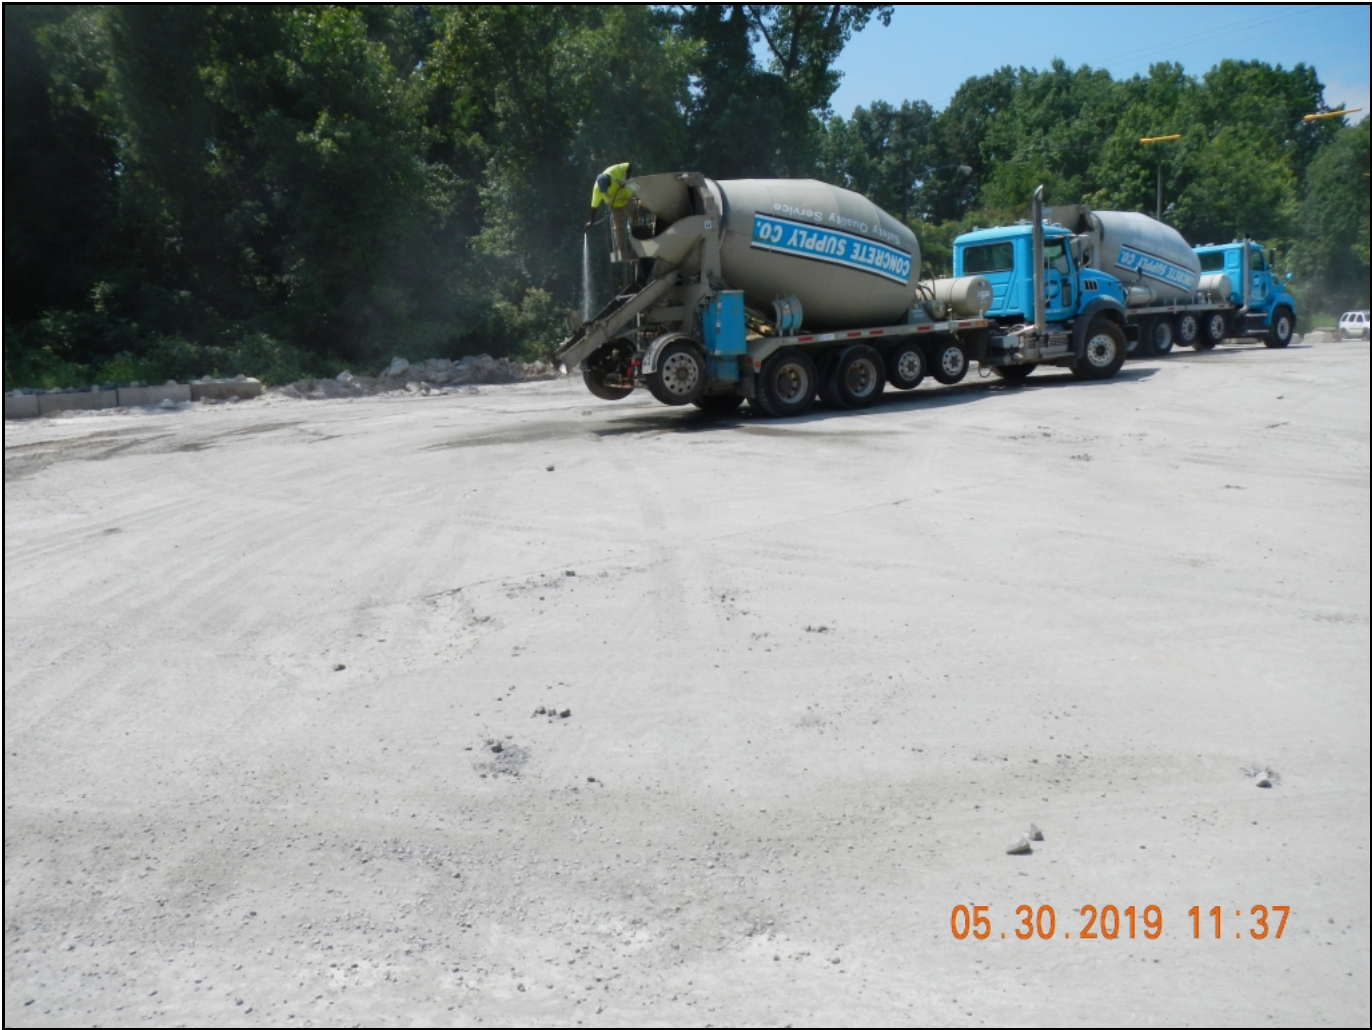
Attributes	
Description	Truck being washed out using self-supplied water in middle of work area. This rinse-water was flowing towards the basin in photo DSCN1803.

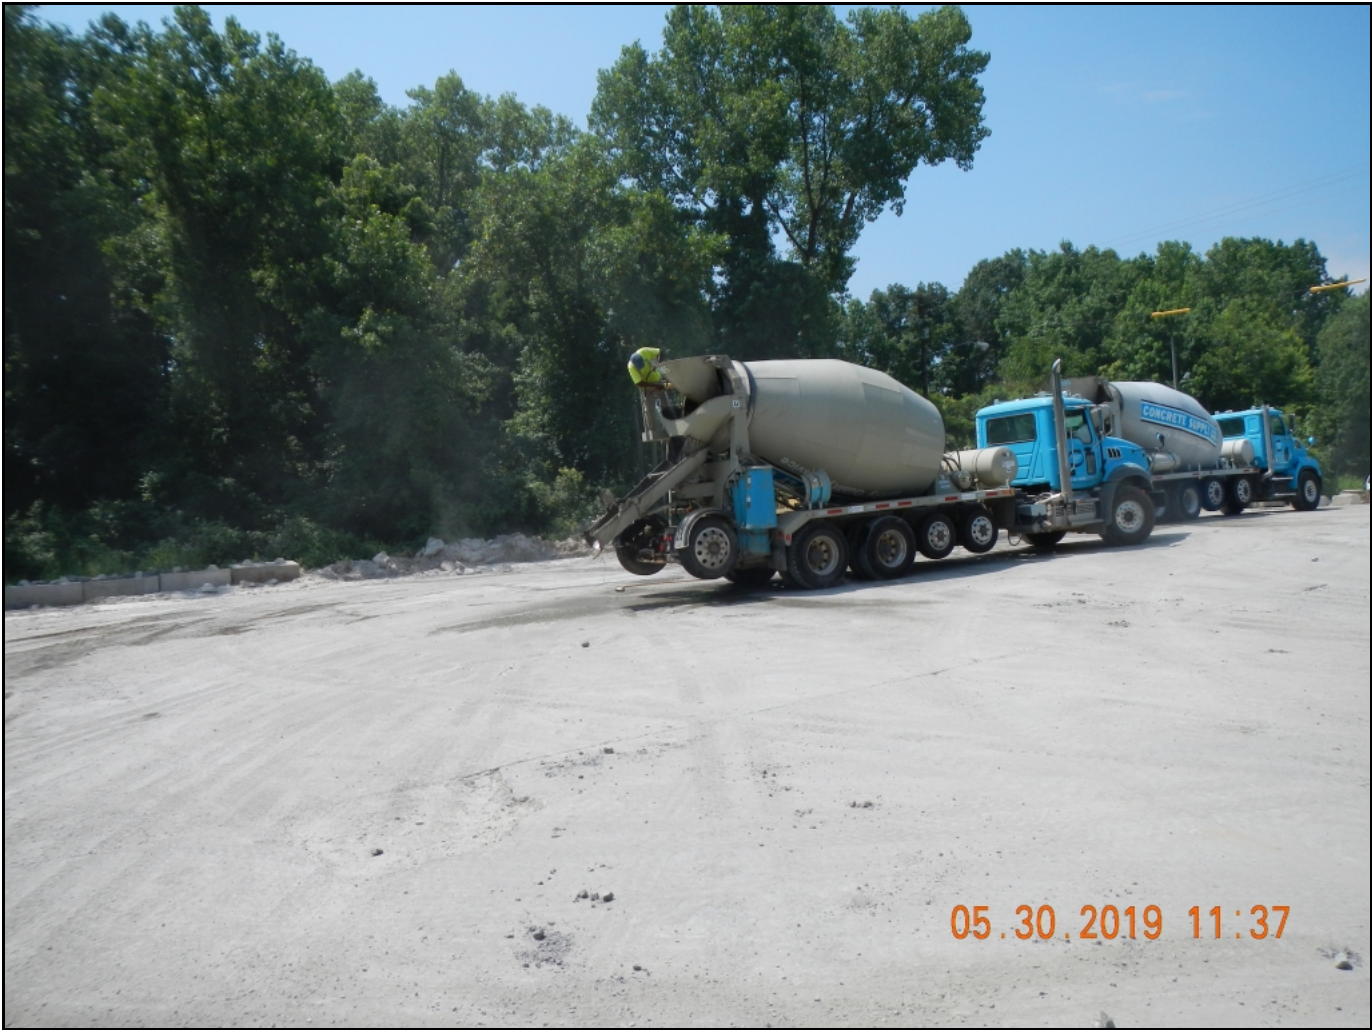
Attributes	
Description	Truck being washed out using self-supplied water in middle of work area. This rinse-water was flowing towards the basin in photo DSCN1803.

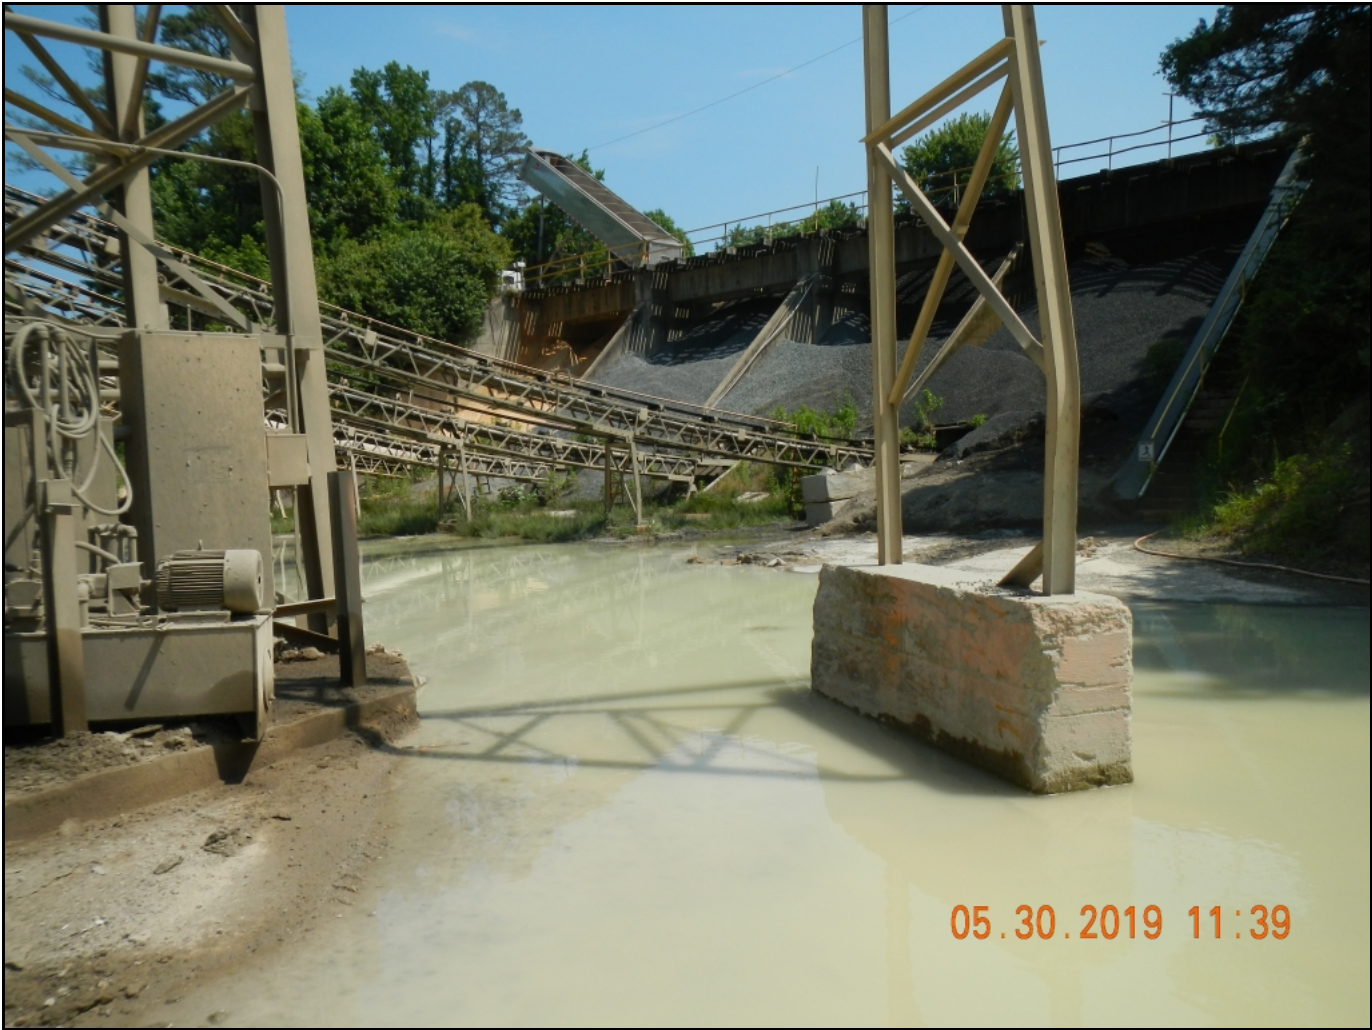
Attributes	
Description	Another view of drainage from belt/storage area. Looking northerly.

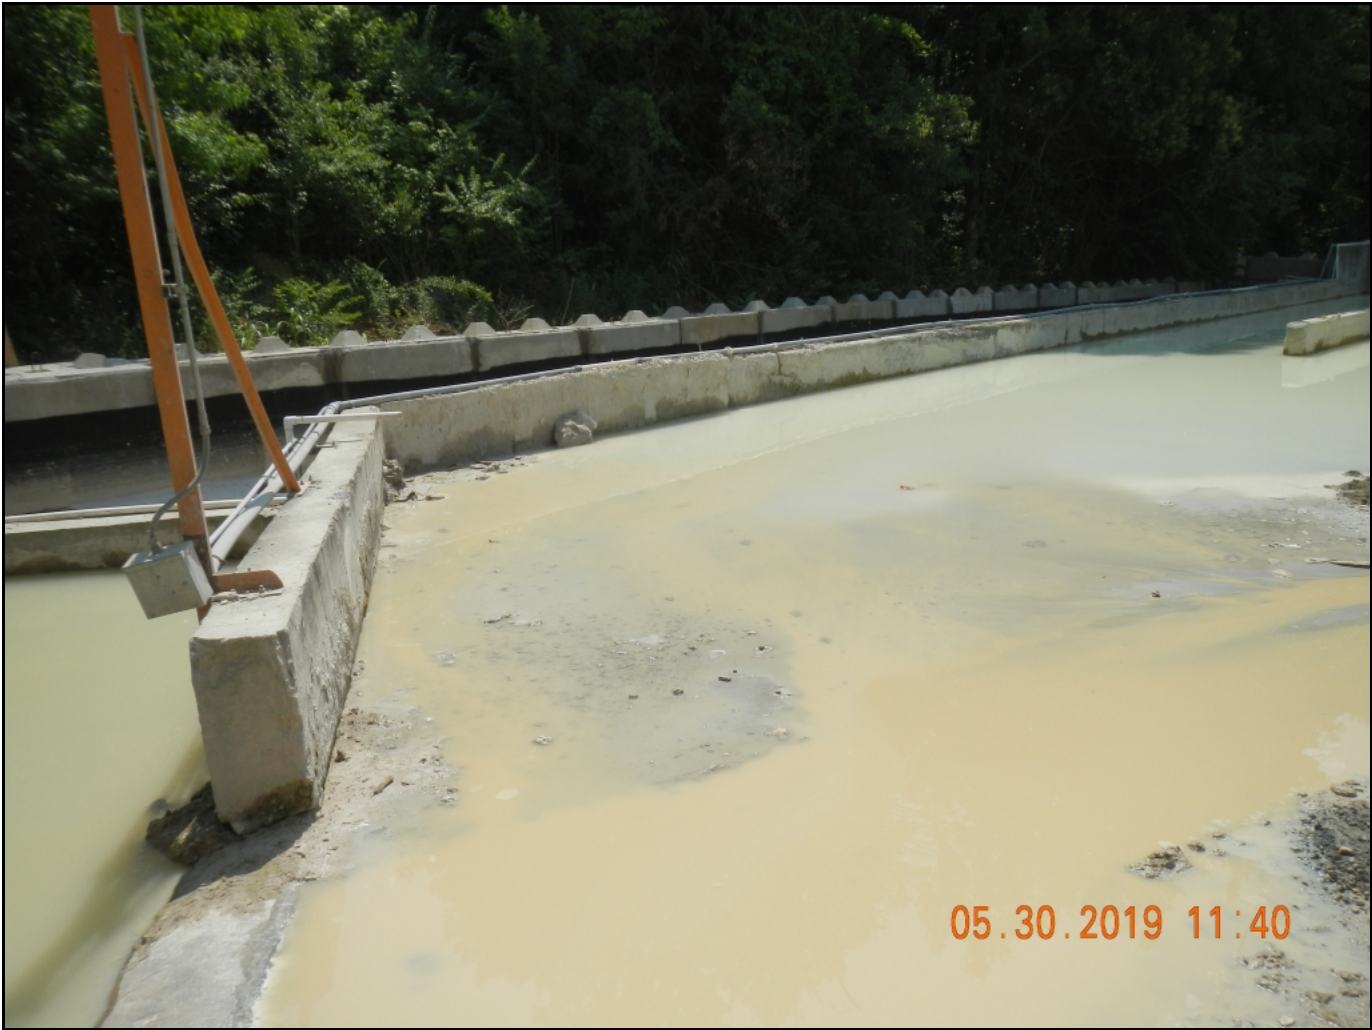
Attributes	
Description	Northerly end of basin capturing stormwater runoff from most of yard area.

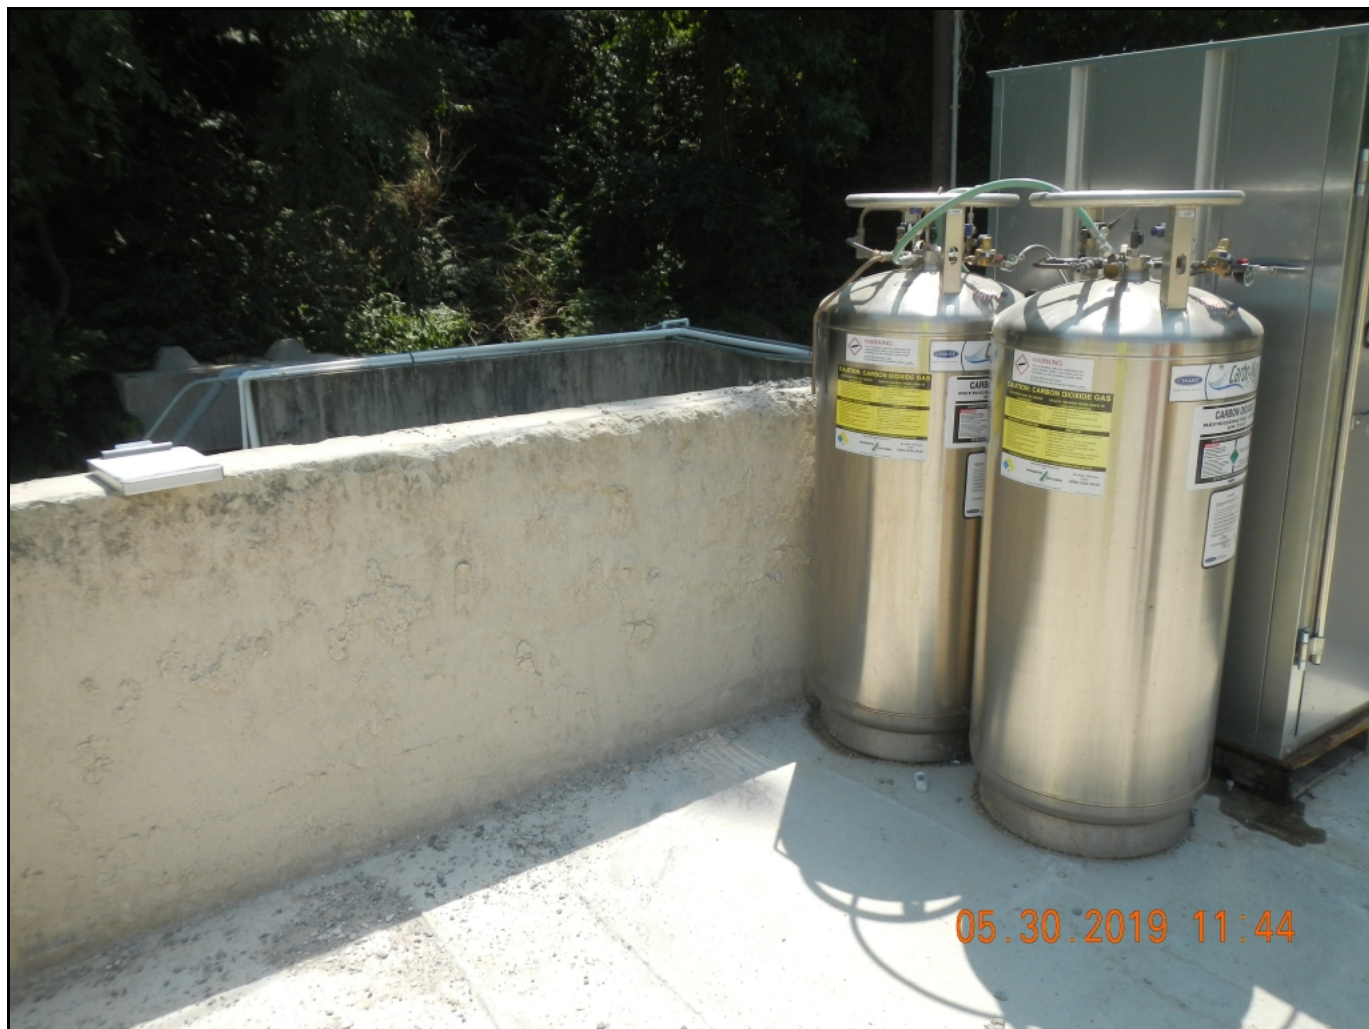
Description	View of CO ₂ tanks, and portion of control shed for CO ₂ application to wastewater and stormwater for pH adjustment in the final holding basin prior to discharge. System was installed in March 2019. Water is only discharged when necessary; most water is recycled into products. Treatment basin is behind wall in middle of photo. PVC pipe control lines and feed lines are visible.
-------------	---

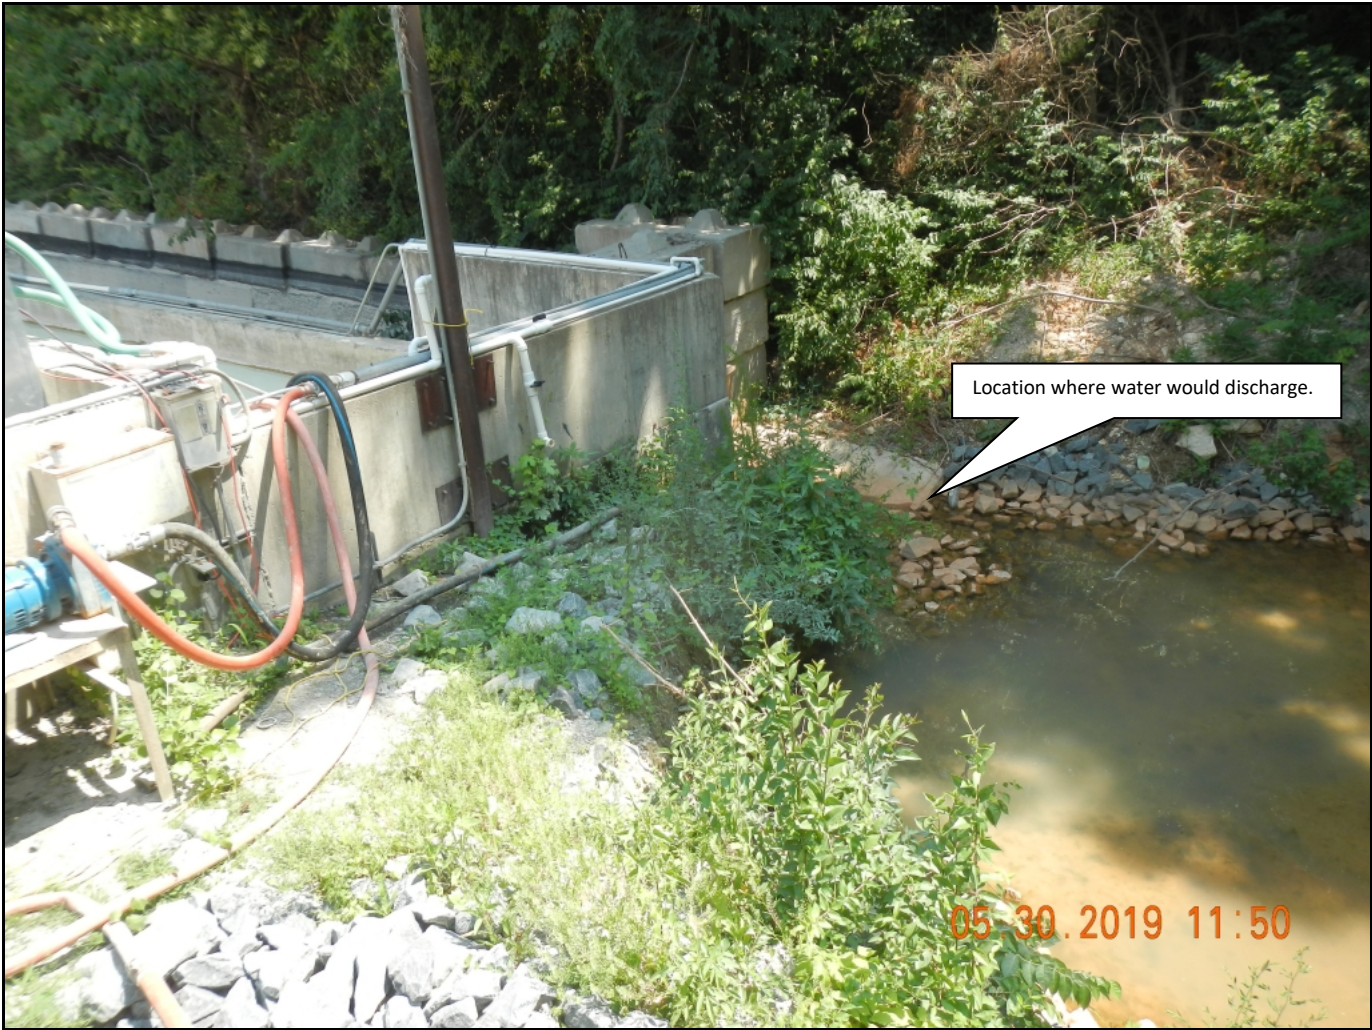
Attributes	
Description	First of four panning shots of the outlet structure area. Staff stated that the water in the ditch was from the adjacent roadway, backing up towards their outlet structure. Outlet structure observed as not discharging at time of inspection. CO ₂ pH adjustment feed lines and return lines are visible on the wall. Outlet opening itself is not visible in this picture. Poured concrete wall upper left separates two capture basins from treatment basin. Stacked block with liner – left of photo, background, is basin where water set for discharge is accumulated for treatment. Discharged water would mingle with muddy water in right foreground.

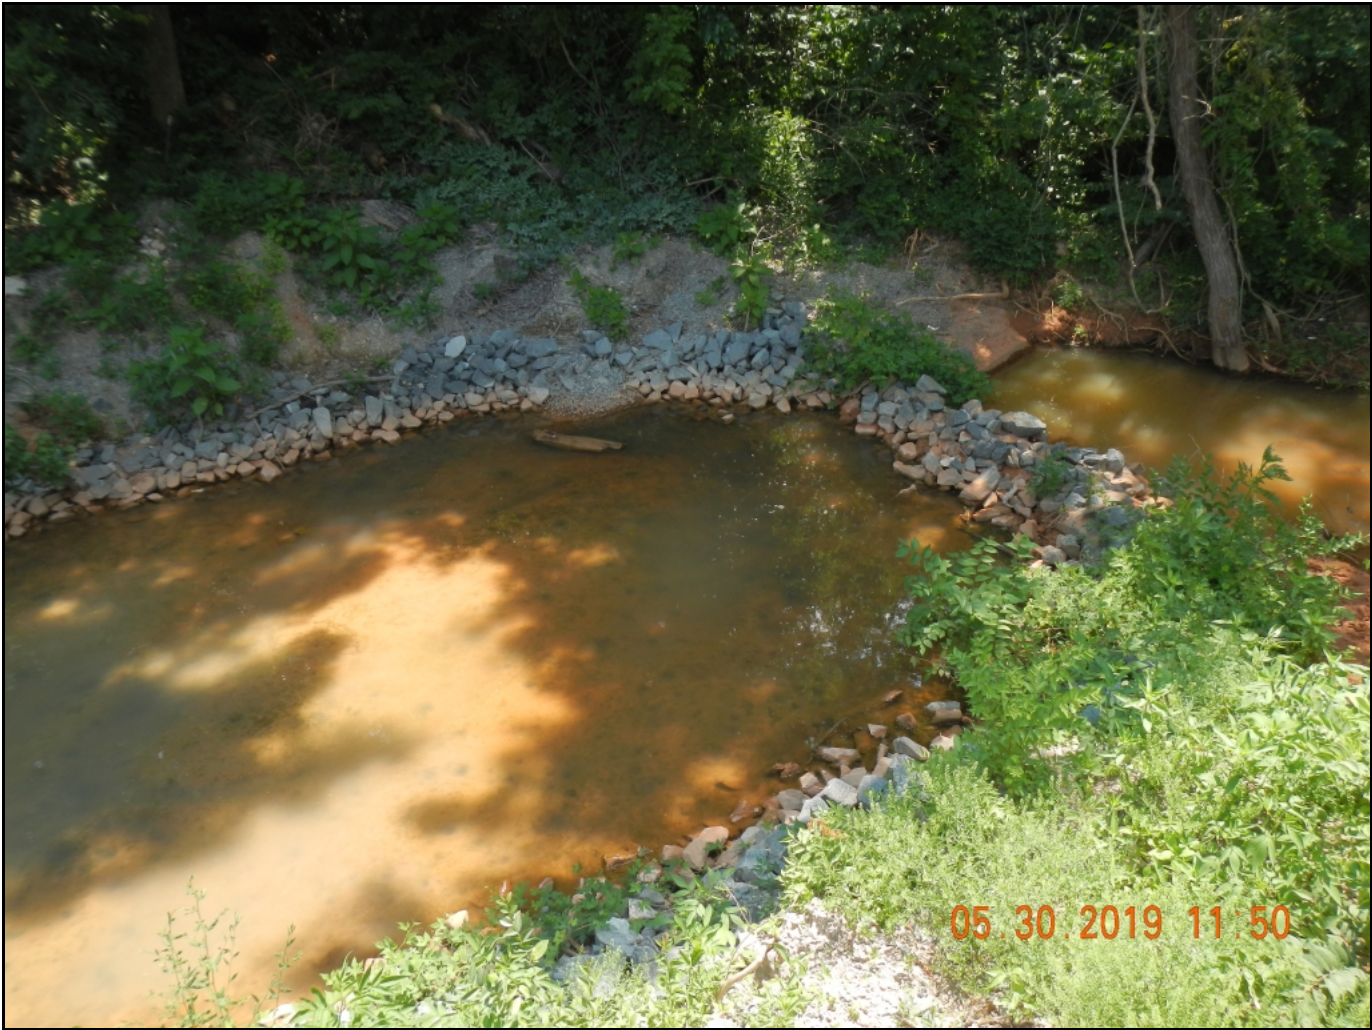
Attributes	
Description	Second of four panning shots showing receiving ditch with muddy water, stated to be from roadway runoff. Looking easterly. Flow would traverse left to right.

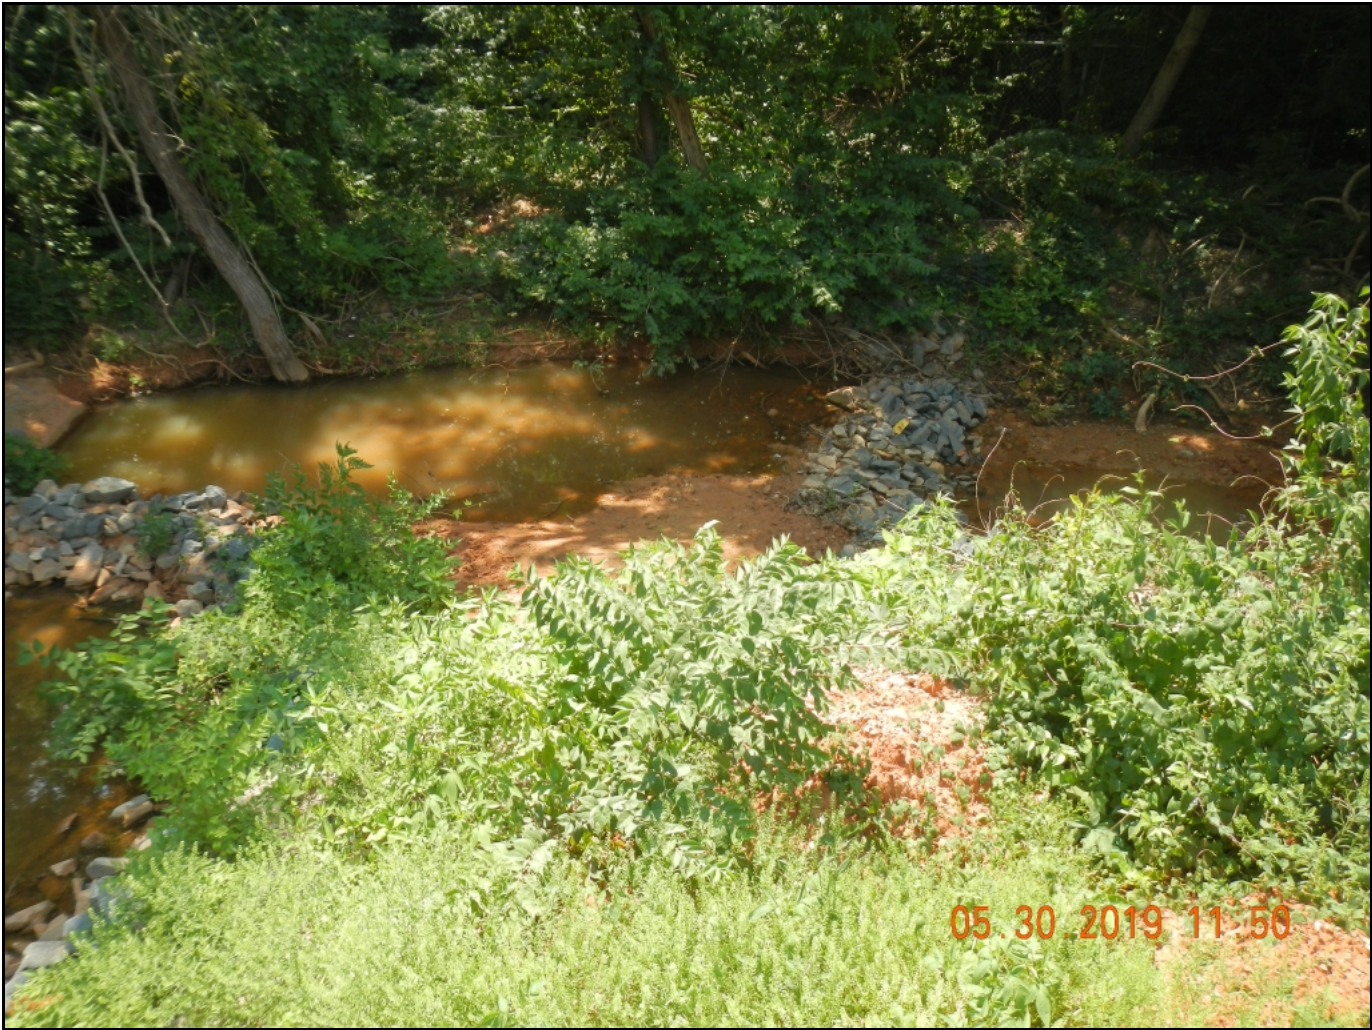
Attributes	
Description	Third of four panning shots of ditch between facility and Tyvola Road.

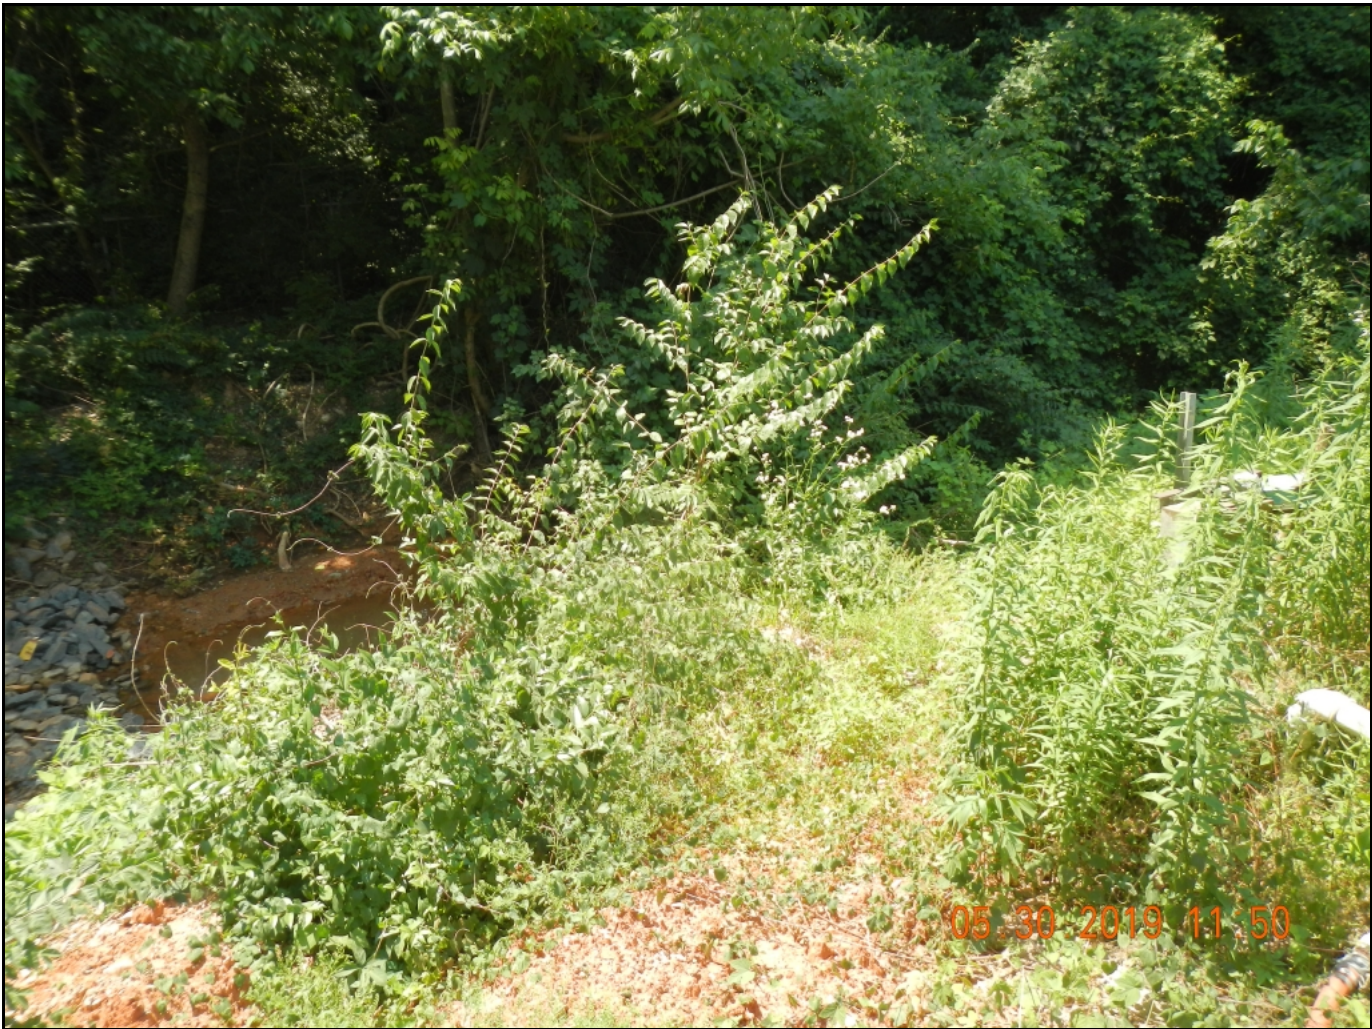
Attributes	
Description	Fourth panning shot of discharge area. Flow goes out of view into vegetated area along Tyvola Road in a westerly direction. Facing southerly.

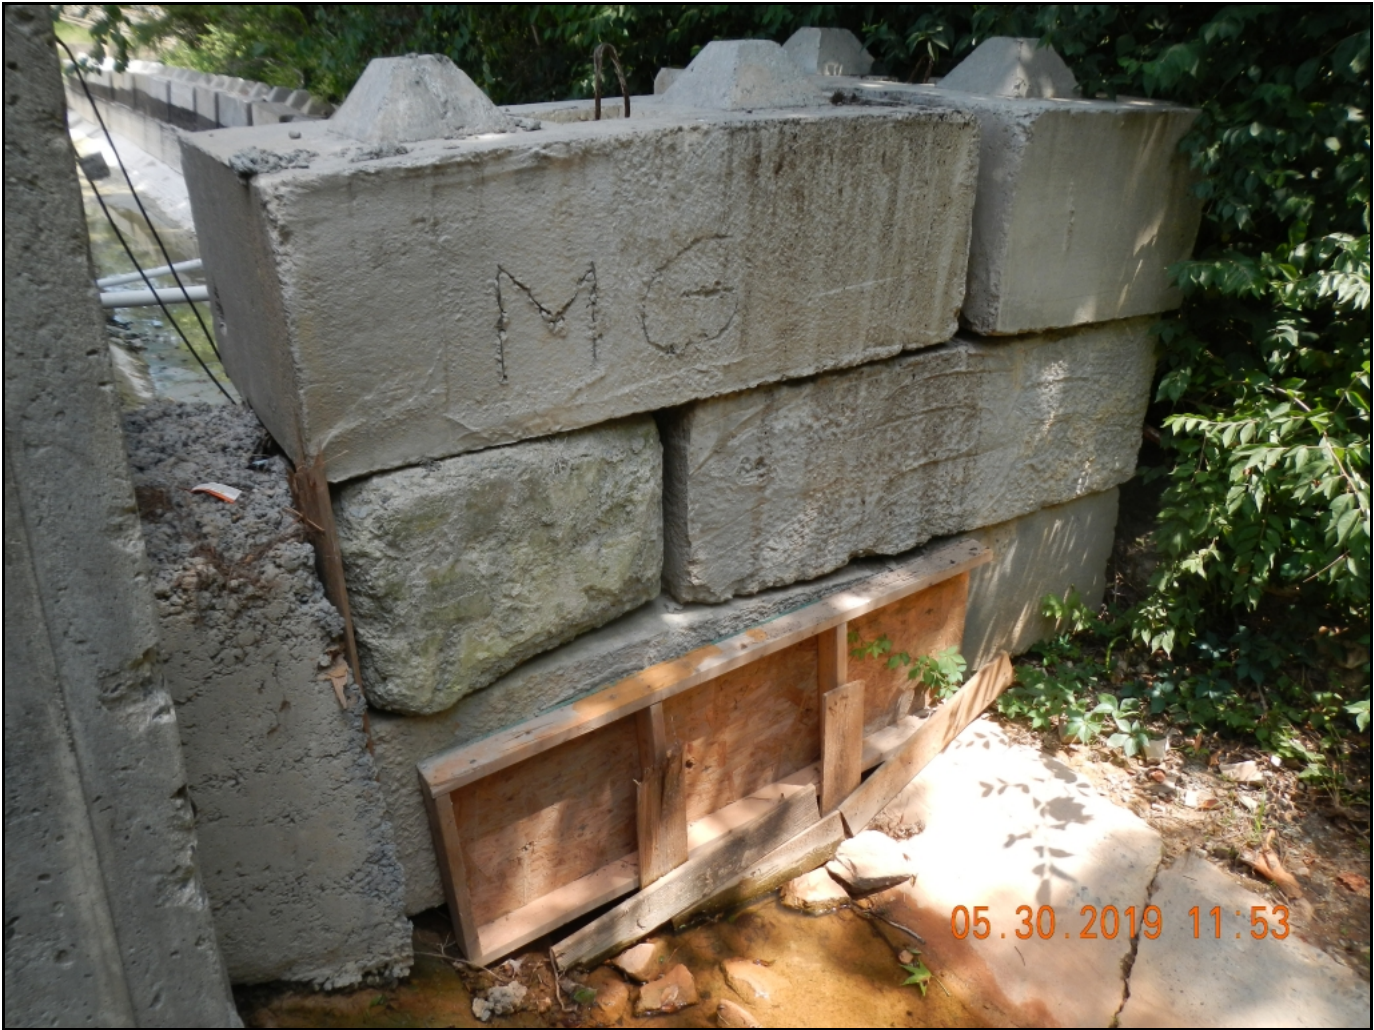
Attributes	
Description	Photo of outlet structure from outside of basin. Water was present at the bottom of the structure but was not flowing. Staff indicated that the system was not discharging. The pre-discharge basin was largely empty (upper left of photo).

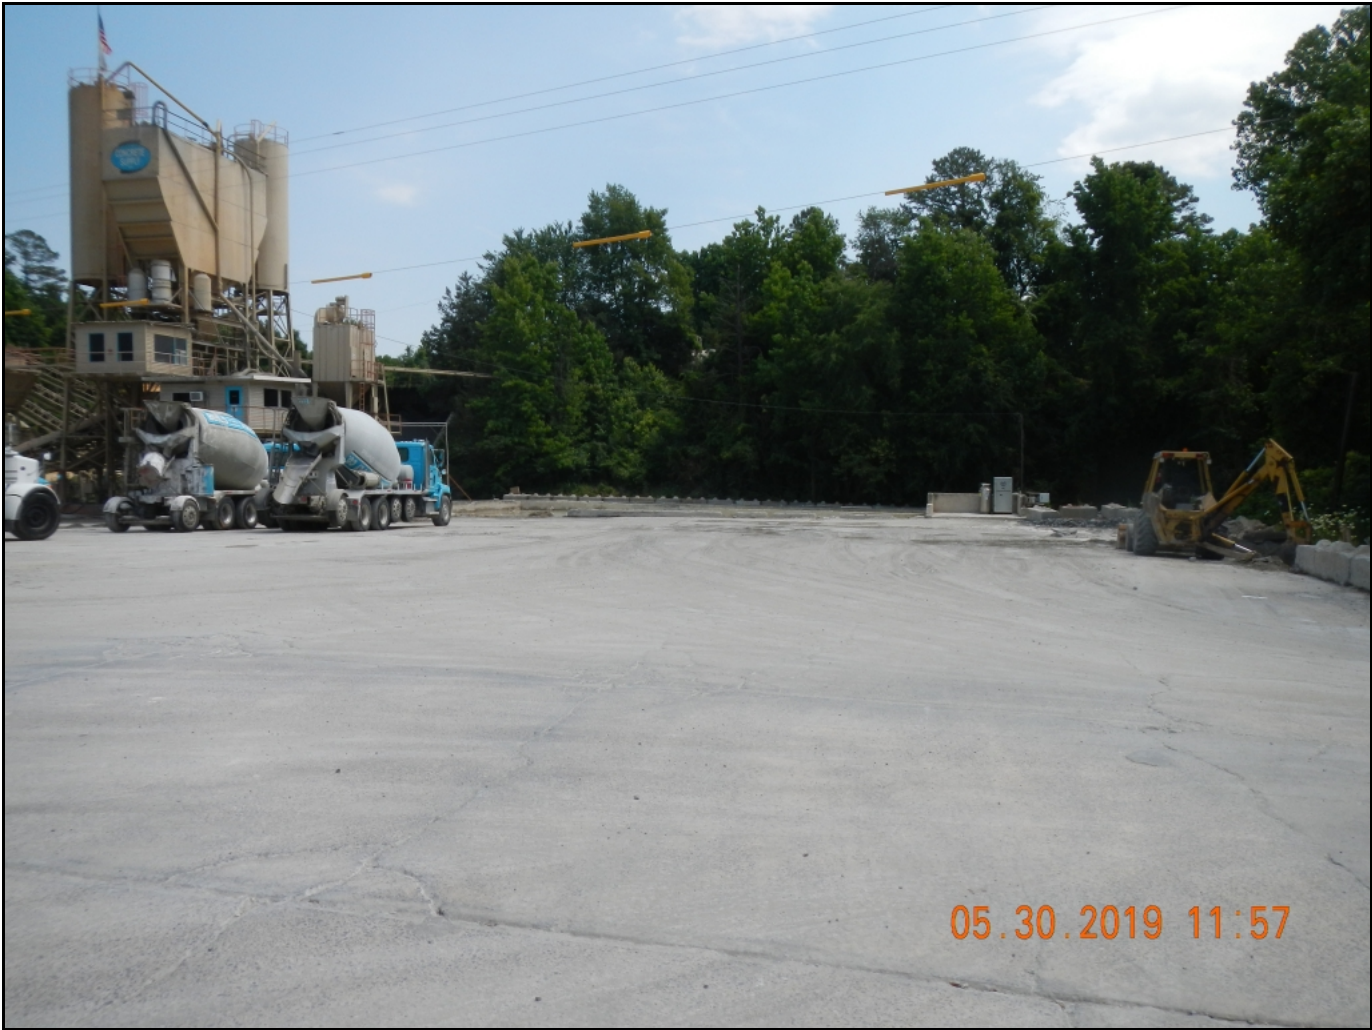
Attributes	
Description	Looking down-gradient from center-south of paved truck area, looking roughly ENE.

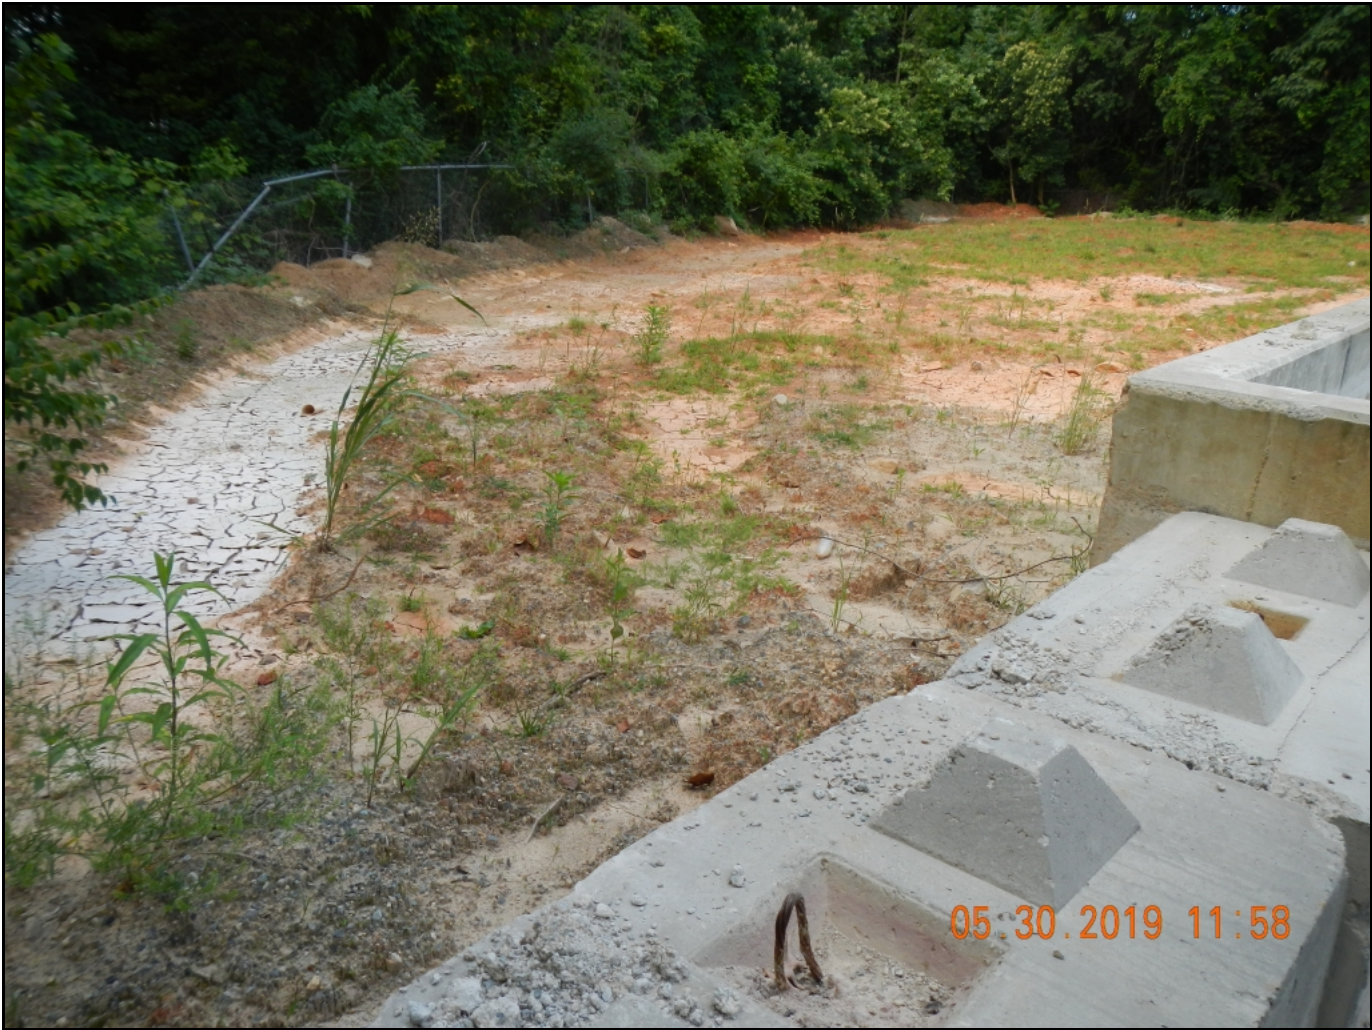
Attributes	
Description	View of former pond area that is no longer used for storage, in SW corner of work area. Limited runoff can still enter this area, but largely percolates. Berm visible in upper left of picture surrounds whole area. Formerly used for storage, the pond was taken out of service and concrete materials were removed. There is an adjacent truck wash station; the corner of poured concrete basin is just visible on right of photo. See DSCN1812.
